Early degradation of silicon PV modules and guaranty conditions

M.A. Munoz^{a,*}, M.C. Alonso-García^b, Nieves Vela^b, F. Chenlo^b

^b Photovoltaic Laboratory, Renewable Energy, CIEMAT, Avda. Complutense, 22, 28040 Madrid, Spain

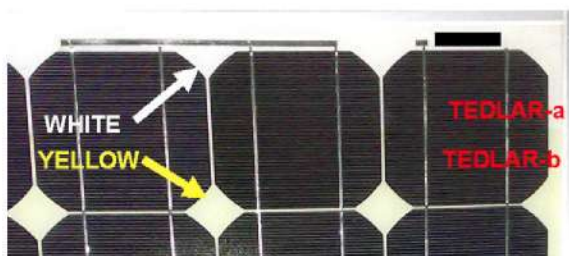
In some PV modules, yellowing appears in some areas but not in adjacent areas with a different polymeric encapsulant of a different origin or characteristics. This should mean that yellowing appears in polymeric encapsulant instead of in the adherent element (usually EVA) but also that EVA was not present in the same way in both areas

of the PV module where different polymeric encapsulant was used. Fig. 1 shows an example of how the yellowing effect appears only over an area but not in adjacent areas.

Fig. 1. Yellowing over an area of a PV module.

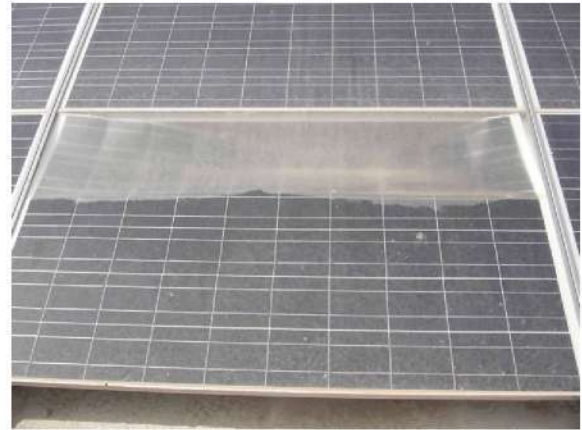
Delamination is more severe if it occurs in the borders of the module because, apart from the power losses, it causes electrical risks to the module and the installation. Fig. 2 presents an example of how an extreme delamination could destroy a PV module when the defect appeared after barely a year of operation in a plant. Delamination is more common in hot and humid climates. When moisture enters, different chemical reactions occur, and some cause degradation of different parts of the module. Migration of different elements through the encapsulant can react with and degrade the module. The result is often the corrosion of metals involved in the structure of the module. In such cases, the resistance could increase or an electrical failure could appear. Delamination is also related to a transmittance loss, as materials are not well optically coupled and a part of the light escapes.

Fig. 2. PV module with severe delamination. A half of the back polymeric encapsulant fell.

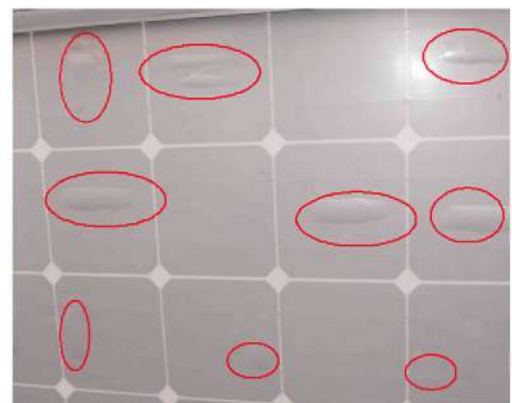
A module containing a high number of bubbles in the back side in Fig. 3 can be observed. They usually appear in the centre of a cell, perhaps due to a different adherence of the cell caused by the high temperature. The bottom IR image in Fig. 3 was obtained from a PV module containing bubbles and demonstrates how a lower temperature in the back cover is detected where a bubble is situated. The bub-

Fig. 3. Bubbles on the back side of two PV modules.

ble forms an air chamber, and although the air temperature in the chamber appears lower than in the adjacent cells, the cell temperature is actually higher because the heat of the cell is less dissipated.

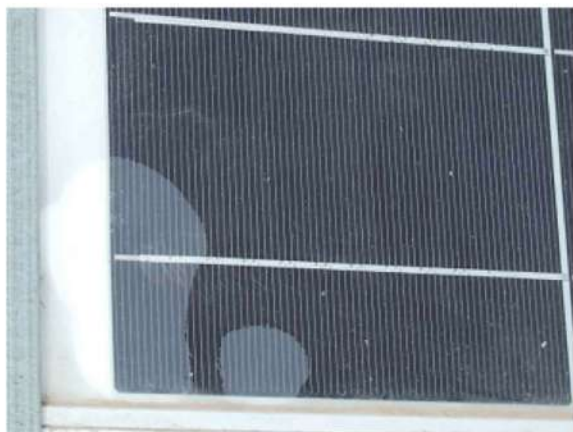
In Fig. 4, it can be observed how bubbles can also appear on the front side of a PV module between the glass and the cells. In this case, the bubbles are caused by a detachment between part of the cell and the glass. This kind of defect is not very common on the front side of the module. Bubbles usually do not appear because cells are more rigid than polymeric encapsulant. Air or gas is accumulated in the bubbles probably due to some chemical reaction as in the case of bubbles on the back side. In the case of bubbles on the front side, apart from an excess of heating effect, a reduction in the light that can reach the solar cell may occur, as there is a decoupling of the light, and the reflection is increased.

Fig. 4. Bubbles on the front side of a PV module.

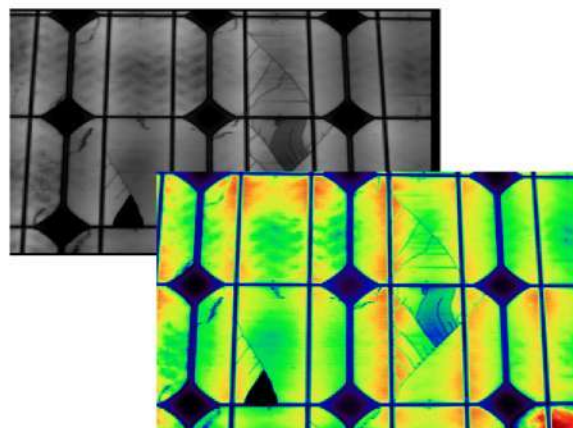
Micro-cracks consist of small cracks in cells usually not visible by sight that may affect both sides of the cell. They produce a loss in cell consistency and a possible carrier recombination path. Sometimes different colour lines can be perceived in the cell, although the cracks are not visible by sight. When modules with these different coloured lines are tested by electroluminescence, there is good accordance between these lines and the micro-cracks observed by EL. Micro-crack areas are darker in EL because they either do not produce light emission or their emission is lower. In some cases, the cracks isolate parts of the cell avoiding current generation, as we can see in Fig. 5.

Fig. 5. Cracks in cells. B&W image and simulated colour image.

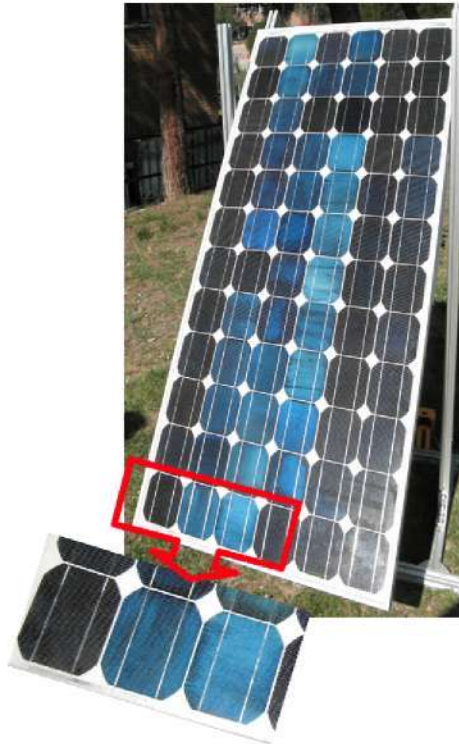
IR characterisation of these modules in different conditions did not show any particular effect that could be associated with the changes in the colour of the ARC. A follow-up of the affected modules should be done in order to detect whether this defect leads to another more severe defect. This defect is related to an oxidation of the ARC and is pointed out by Sanchez-Friera et al. (2011). The defect could be accelerated by an applied voltage of 600 V or higher with respect to the ground. This oxidation of the ARC could cause loss of adherence between the cells and the glass.

Fig. 6. Decolouring of cells due to a change in anti-reflective coating.

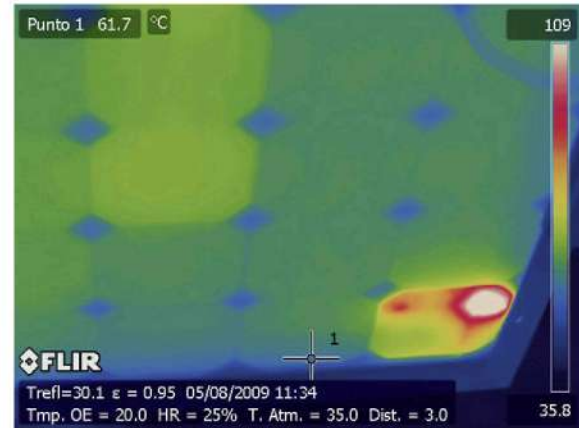
Fig. 7. Thermal analysis, where a cell operating at a higher temperature than the rest can be observed.

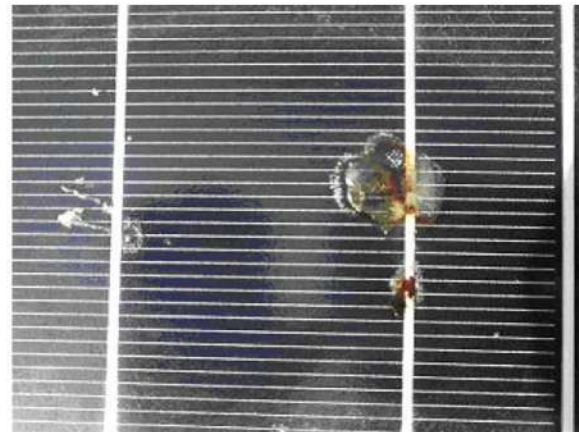
If the hotspot is caused by a shunt (a shortcut from one side to the other side of a cell) or an error in the interconnection between cells also generating a shortcut, the hot spot is directly related to an error in the manufacturing of the cell or of the PV module. Furthermore, if a cell generates a lower current than the rest of the cells (known as mismatch), a hot spot appears in the form of a whole cell operating at a higher temperature than the rest of the cells (Fig. 7) and can be considered an error in the manufacturing of the PV module. The hotspot could cause damage to the cell or the encapsulant within a short time of operating (Herrmann et al., 1997) (Fig. 8).

Fig. 8. This image represents how a hot spot can damage a cell.

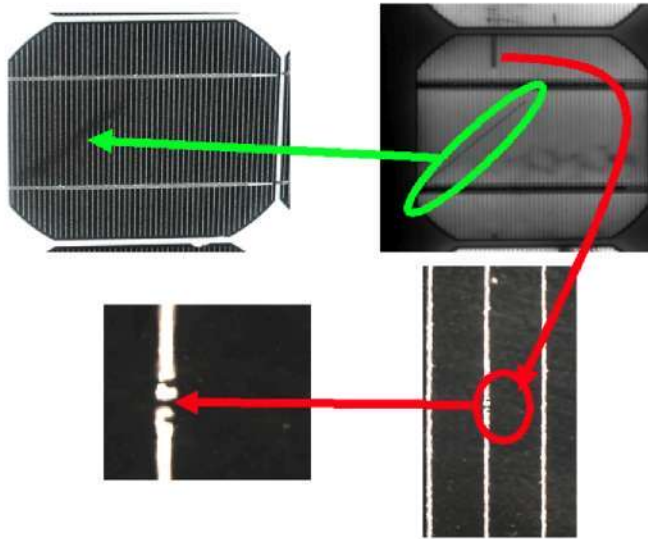
Lines that sometimes appear over a cell could be caused by a crack in the cell. It is likely that a crack led to a chemical reaction or a migration that affected the anti-reflective coating and upper layers and resulted in a visible line (Fig. 9). Using the EL method, the defect appears as a crack. Another defect consisting of a broken ribbon can also be detected. In the figure, two defects can be detected but only one of them is visible at sight as a line over a cell. In this case, the other defect can be observed using a microscope.

Fig. 9. Two defects detected with an EL image. The defect in the left upper image is visible by sight and consists of a crack in the cell. It can be detected using the EL method. The defect in the lower left image is only detectable using a microscope.

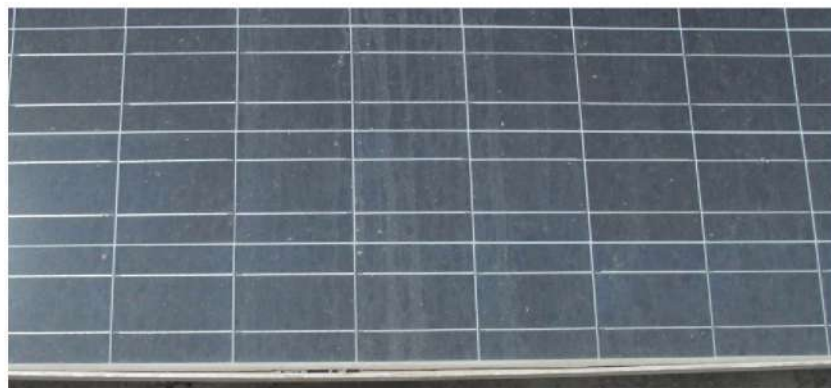
The detachment of the frame consists of a separation of the frame from the rest of the module. When a detachment of the frame occurs, water can enter the module and problems such as electrical risk apart from corrosion may appear. The main cause of frame detachment is a defect in the element that acts as the adhesive and sealant, usually silicone, which should attach the frame to the set formed by glass, cells, EVA and polymeric encapsulant. Frame detachment sometimes appears after the PV module has been installed. In this case, it could be due to a faulty installation where the module supports excessive weight. An example of this can be seen in Fig. 10. Snow or ice accumulation on the module can also cause a frame detachment.

Fig. 10. Detachment of the frame.

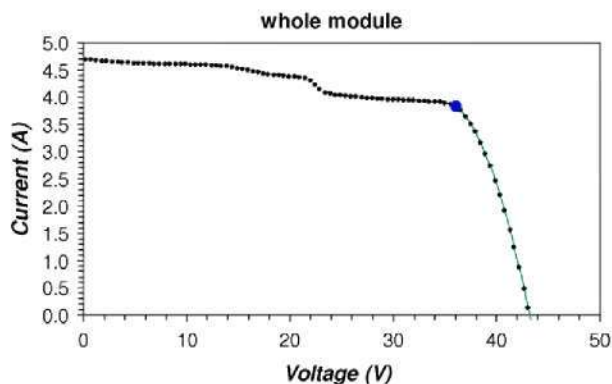
An $I-V$ curve of a defective PV module is shown in Fig. 11. It seems to have a problem on a string of cells that causes a jump in the curve. Using the EL image technique (Fig. 12) the defect in the string of cells can be confirmed, as they provide less luminescence.

Fig. 11. Electrical I - V curve of a defective module. It seems to have a problem on one string of cells.

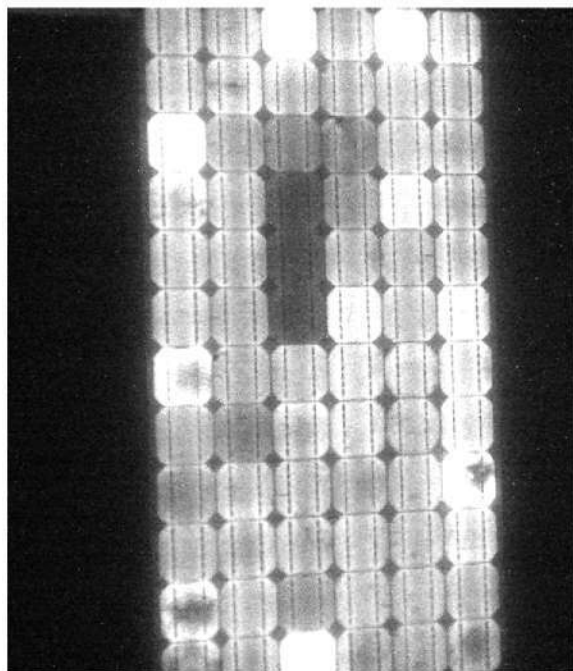
Fig. 12. EL image of the previous PV module where a defect in some cells of one string of cells is confirmed.

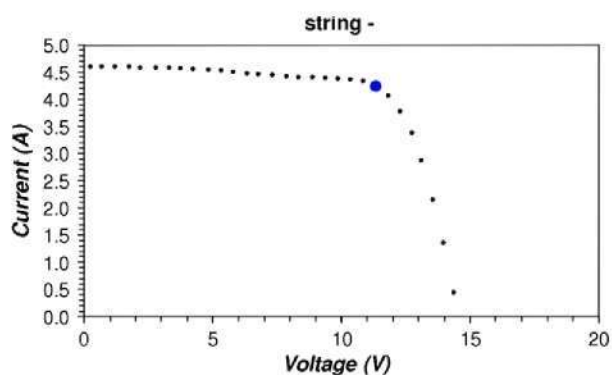
Fig. 13. I - V curve of the left side string of cells of the module. It is not perfect but it is admissible.

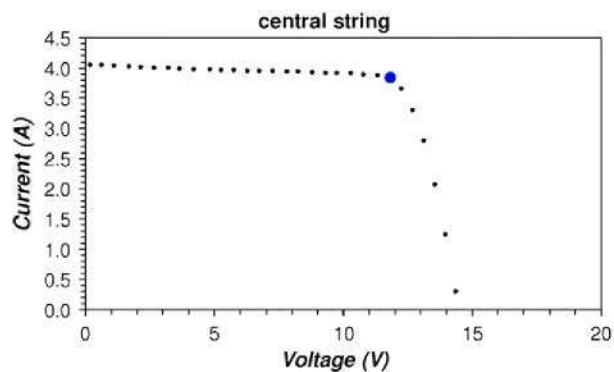
Fig. 14. I - V curve of the central string of cells of the module. The current string is clearly lower than the rest of strings.

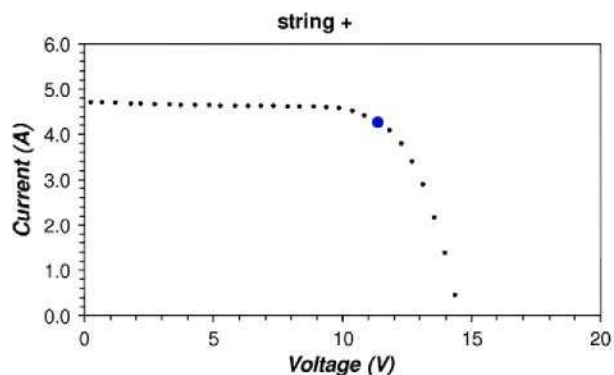
Fig. 15. I - V curve of the right side string of cells of the module. It is not normal and has defects.
